## Customer testimonial

VvE Parktoren 2, Rietlandpark, Amsterdam

Additional task 1:

**Investigation of persistent façade leakage on the south side of Park Tower 2**

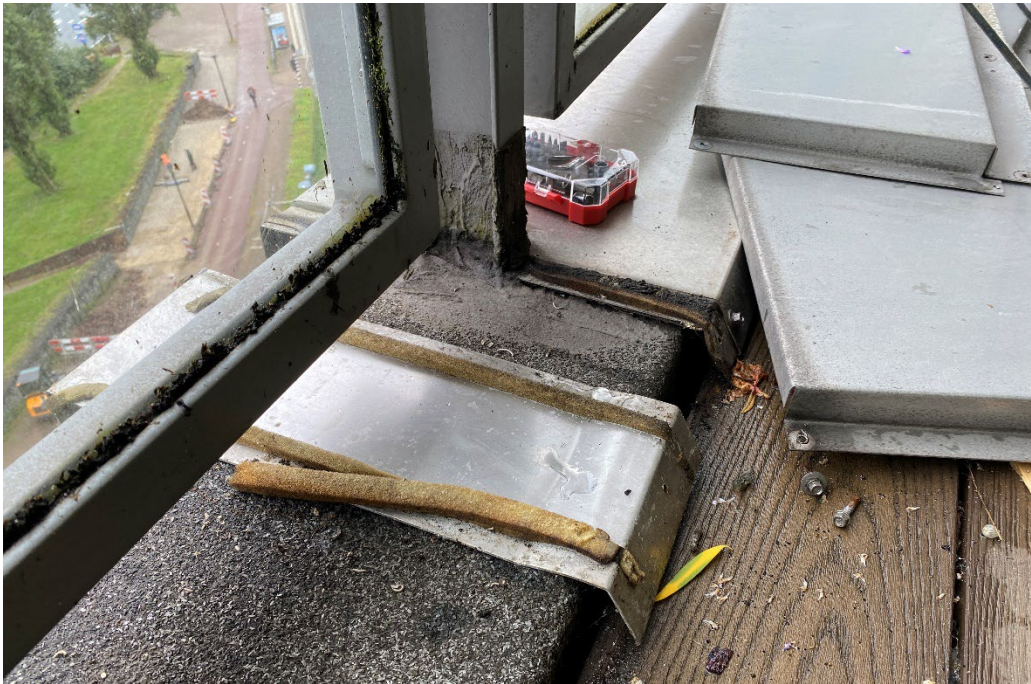
Under the aluminium cover plate that covers the edge of the indoor roof terrace, a search was made for a possible watering-in spot behind the facade cladding underneath. Due to a poor overlap of roofing and drainage sheeting, the problem appeared to be located there.

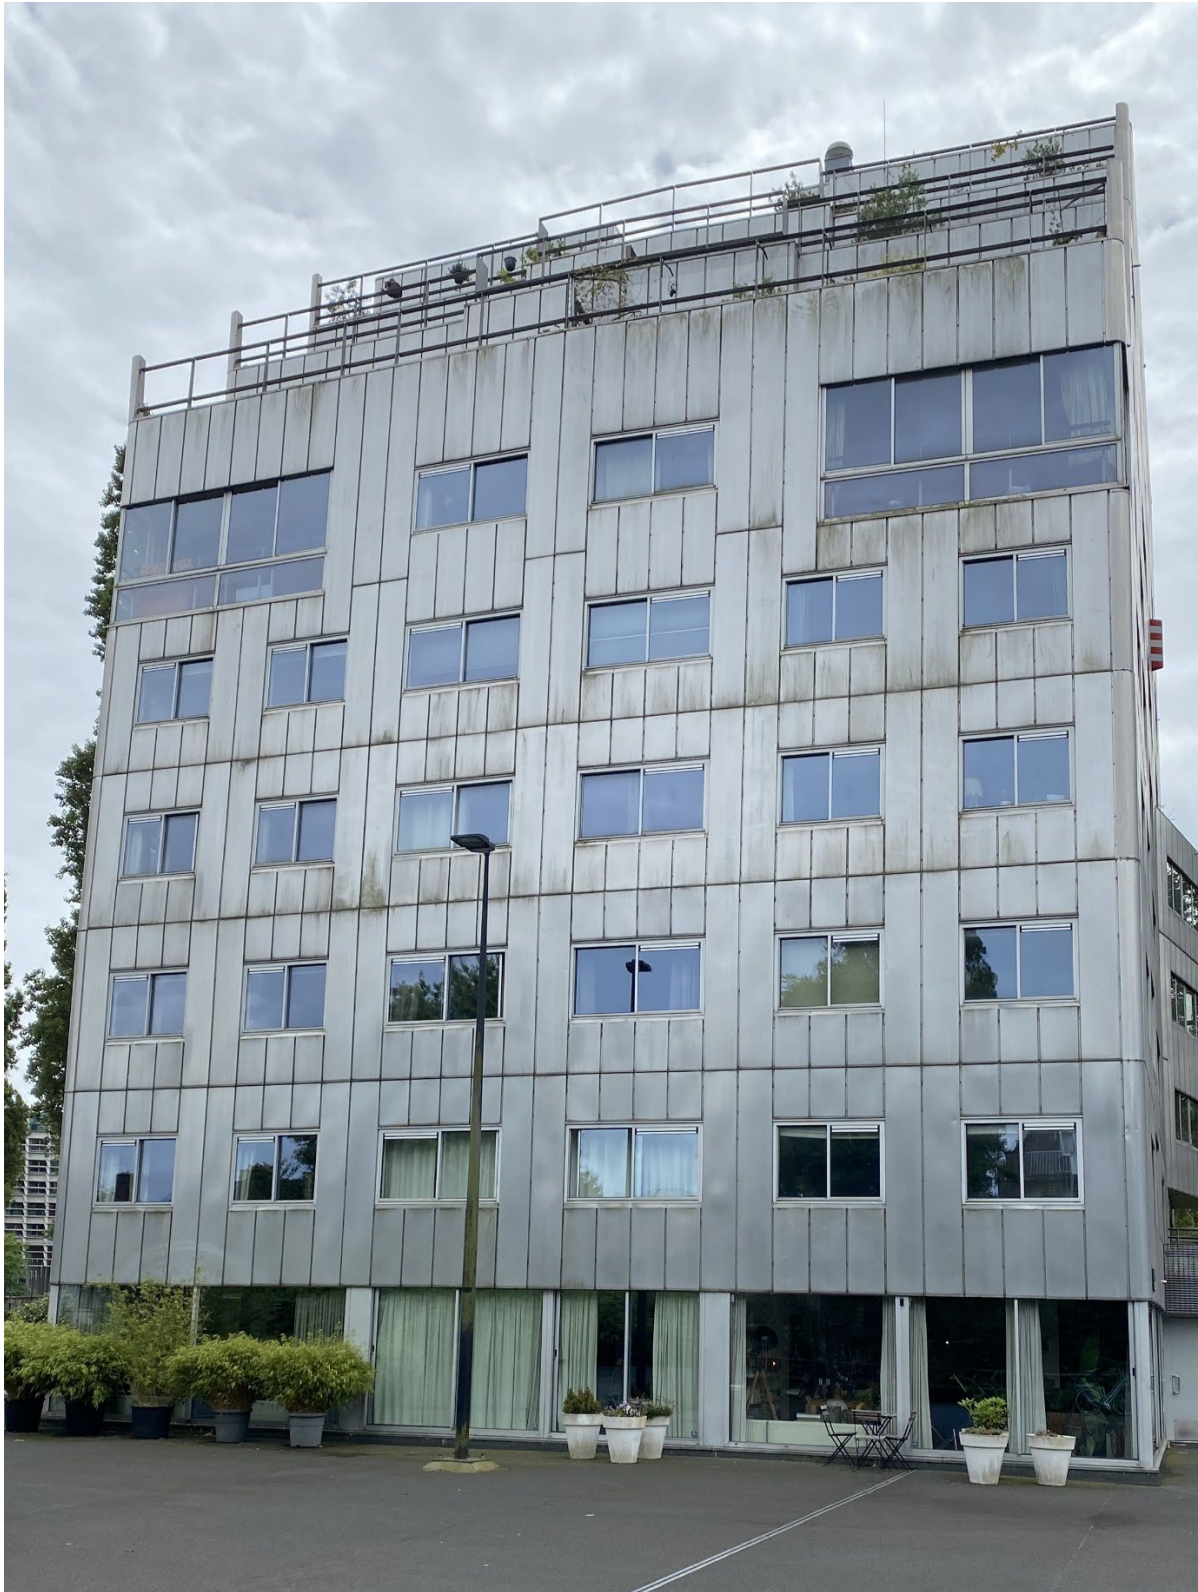
The north facade of Parktoren 2 in Amsterdam's Rietlandpark before cleaning

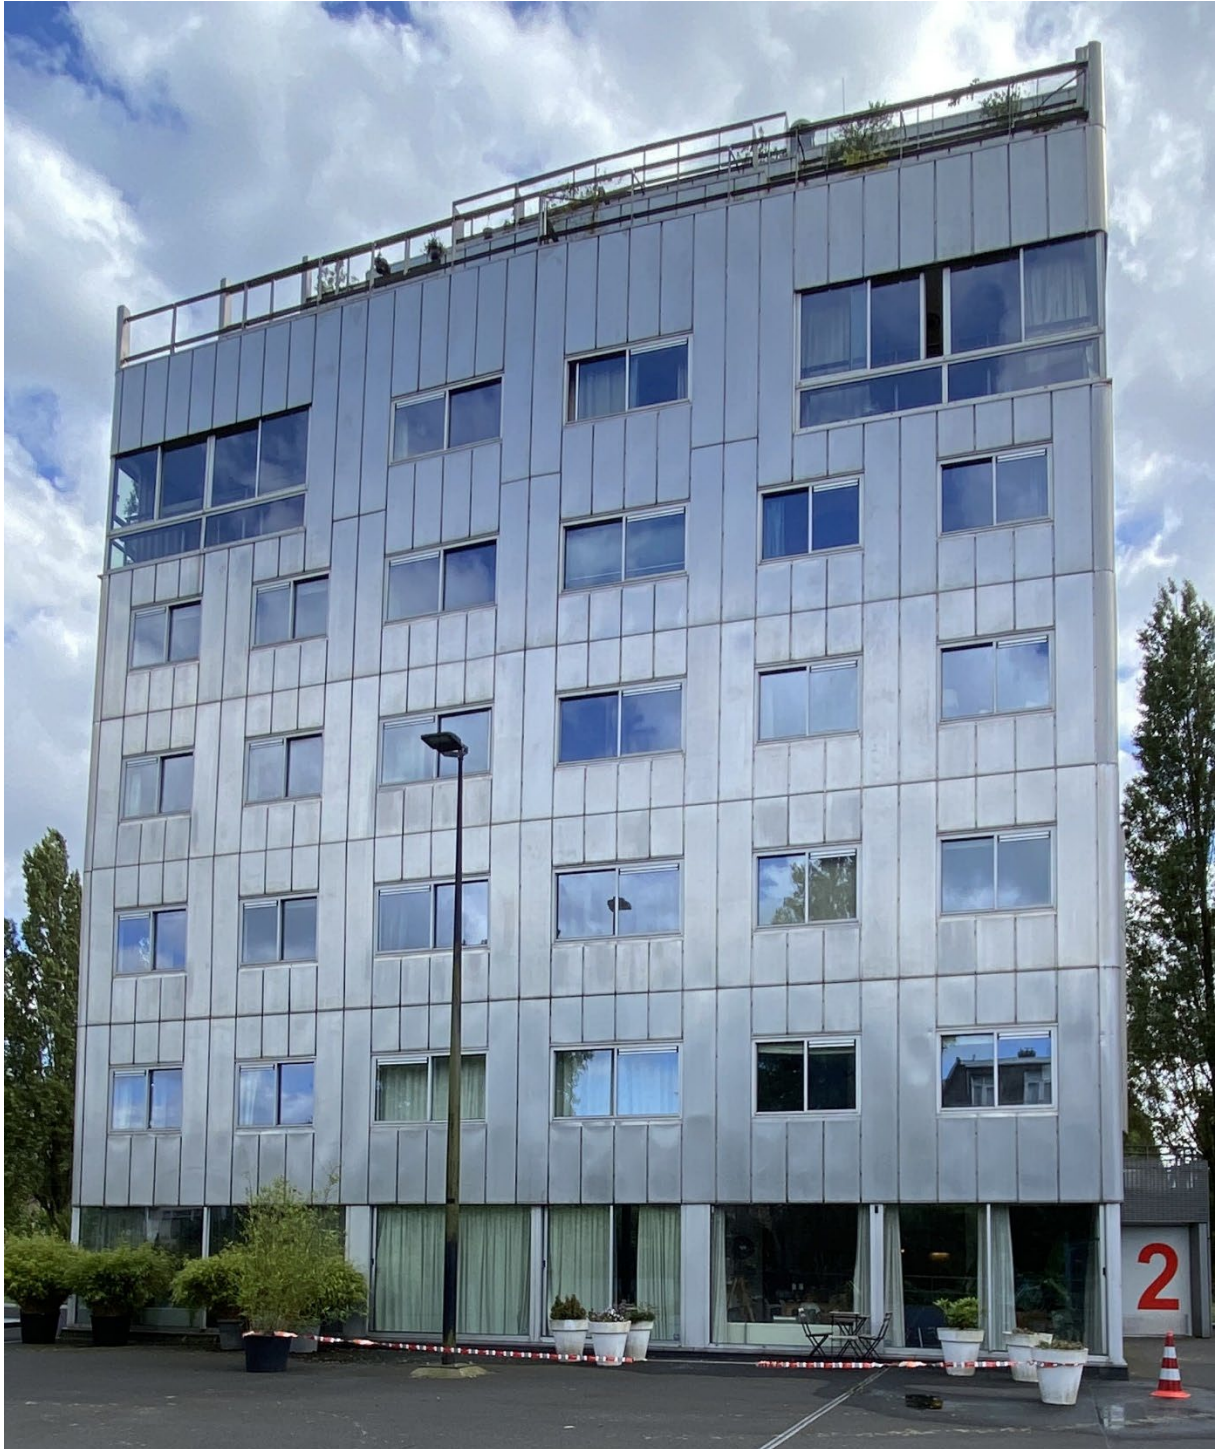
The shiny final result of the cleaned north facade of Parktoren 2  
Rietlandpark, Amsterdam
